# CASE STUDY: Ol Glass

CHIMNEY REMEDIATION PROJECT

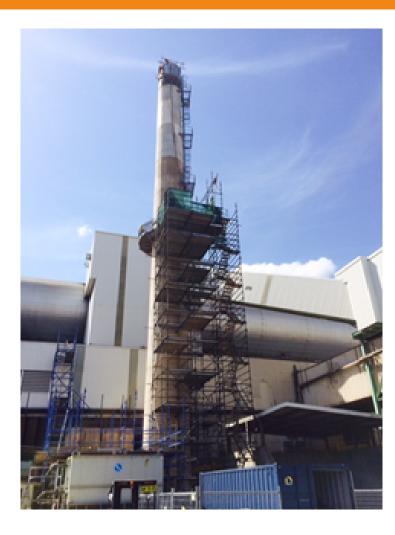
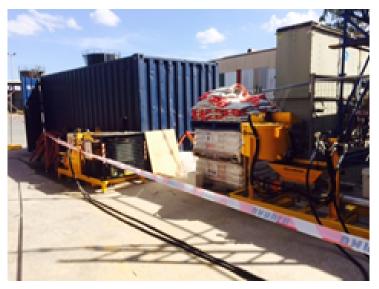
Well known refractory contractor BEROA were contracted to complete the remediation project. The job involved use of abseilers, scaffolding and custom manufactured stainless steel interlocking sleeves used to encase the spoiled concrete chimney. The sleeves were then injected with a Conbextra HS high flow high strength shrinkage compensated precision cementitious grout.

The ChemGrout CG570 was chosen for its ability to produce the torque required to pump the grout material containing 1mm aggregates from ground level to the top of the 55m stack through a 1" grout hose fastened to the scaffold.

Over 1.8 cubic metres of material was pumped in 1.3 hours to the top where the abseiled team inject the grout inside a stainless steel sleeve. Our batch size consisted of 5 bags of pre blended product with ratio of@ 3.8l per 20kg of material. Yield per bag 9.8L flowable.
